Environmental Scan

Edinburg Parks and Recreation Master Plan

4.1 PARK PROFILES

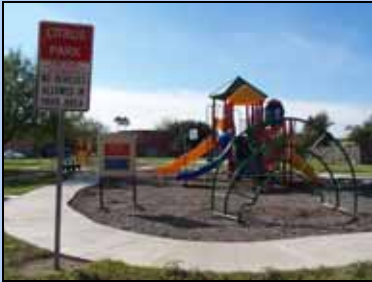
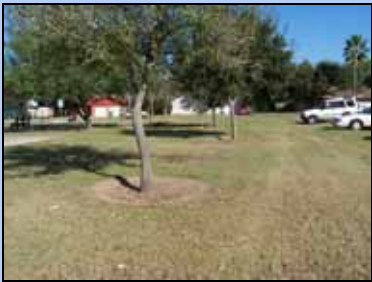
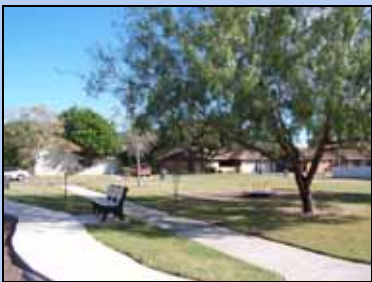
Photo Depiction

Condition: The park is in very good condition relative to other parks in the City. During the park assessment, Citrus Park received a composite score of 0.89. In terms of improvements, the park could benefit from some additional shrubs and/or trees to provide natural screening from abutting residential uses. As depicted in the photos, safety could be improved with the addition of a fence to provide separation between the park and adjacent parking for the multi-family residential units. Safety could also be enhanced by creating perimeter sidewalks along the two access roads – John Avenue to the north and Mary Avenue to the south. Paved areas around the park, not including pavement around the main play equipment, are in need of minor repair/maintenance.

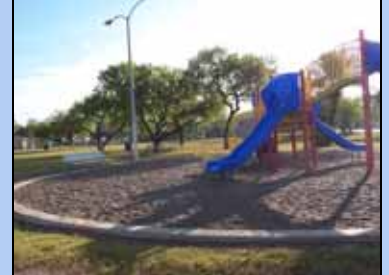
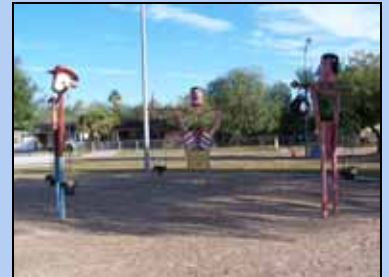
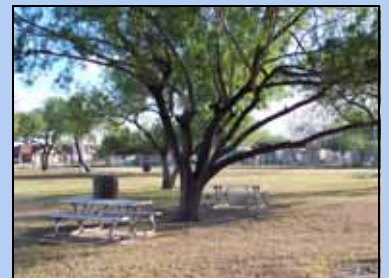
Photo Depiction

Condition: Frontier Park received a composite score of 1.63 indicating that the park is in relatively poor condition. The improvement needs include replacement of the basketball net and repair of the lighting around the basketball playing surface. To improve safety and aesthetics, plant shrubs/trees should provide natural screening. At present, only one street is fenced and no streets have a natural (i.e. vegetative) barrier. To further improve safety, cross-walks and signs are required at all roads that frame the perimeter of the park. Play equipment is in good condition, but one piece in particular would benefit from replacement and or repair.

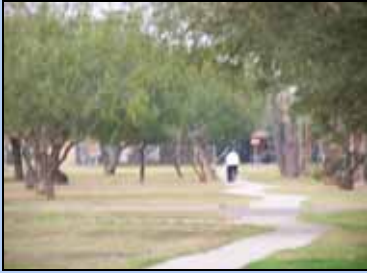
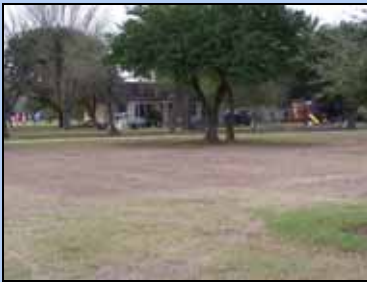
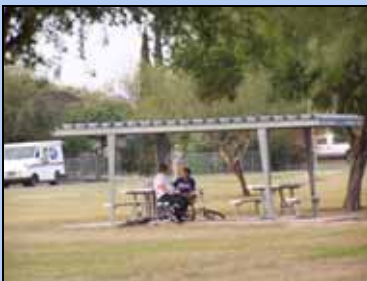
Photo Depiction

Condition: During the park assessment, Cenizo Park received a composite score of 1.63. This score indicates that the park is in poor condition and in need of improvements. Turf re-establishment is required south of Hill Street where the grass is dry and requires re-seeding (see photo). The basketball net also requires maintenance. Safety is a significant issue in that there is no crosswalk at Hill Street, which intersects the park. People that are biking, walking, running, and wheeling must cross the street to go from the north end of the park to the south end of the park, and then back again as the trail loops northward. In effect, there are multiple crossing opportunities and no means to provide for park user safety against vehicle traffic. Safety is also of

concern due to the fact that there is no lighting, which is a requisite improvement. Accessibility must also be addressed. A path should be created from Canal Street to the park's trail. The park's fencing should also be replaced/maintained to ensure consistent coverage. At present, it is unclear where public and private property begins and ends.

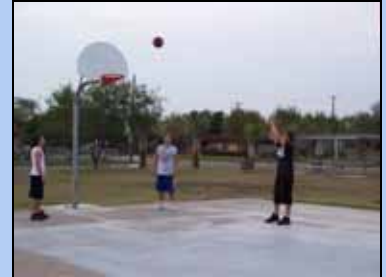
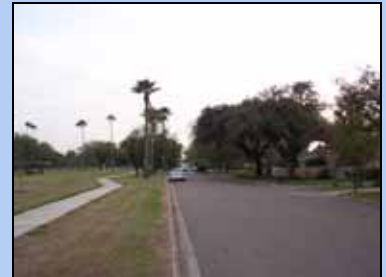
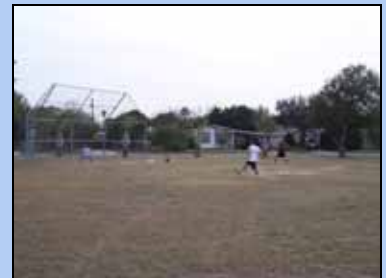
Photo Depiction

Condition: West Park received a composite assessment score of 1.22, indicating that it is in moderate condition. Improvements required relate to improved safety and accessibility. Cross-walks and more signage are required.

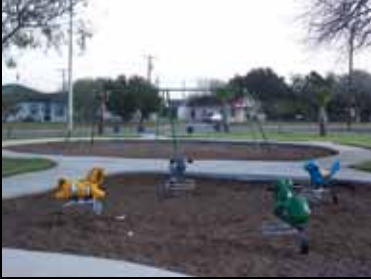
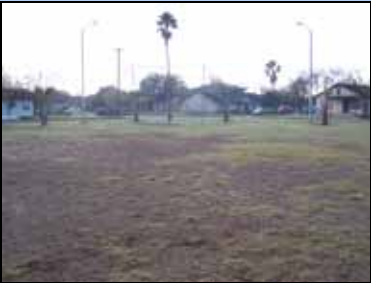
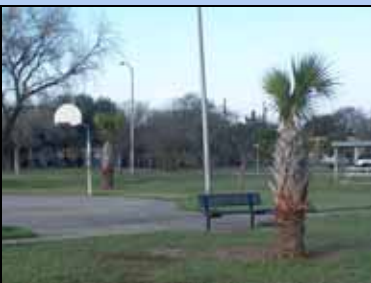
Photo Depiction

Condition: The park received a composite score of 1.80, indicating that it is in poor condition. Playing fields around the backstop require reconditioning (see photo). Crosswalks and street crossing signs are required to improve safety and accessibility.

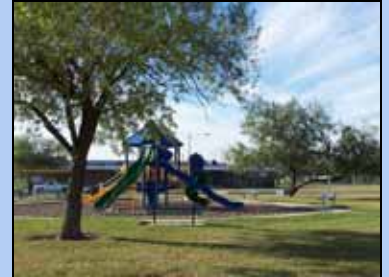
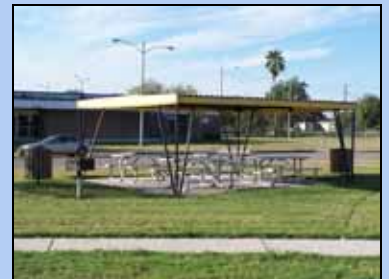
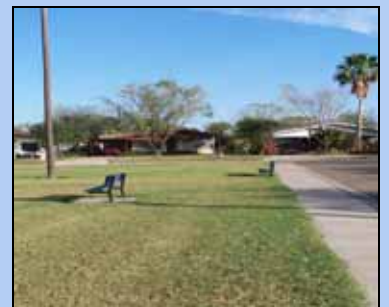
Photo Depiction

Condition: Fountain Park received a composite score of 1.44. As compared to other parks in the City, Fountain Park is in poor condition. Additional vegetative coverage is required to provide shade over benches that line the perimeter of the park and face the street (see photo). There is no fencing or screening other than that which separates the park from the abutting school. Natural screening would be useful to delineate the park boundaries. Attractive fencing could provide added safety. Crosswalks and signs are also required to improve safety and legibility. The basketball nets and playing surface require additional lighting coverage.

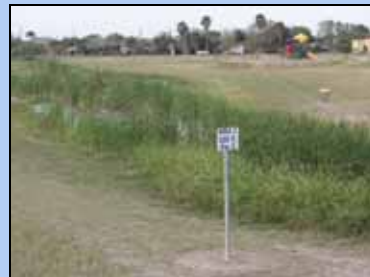
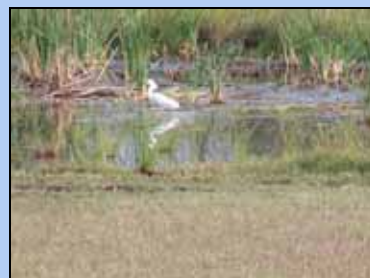
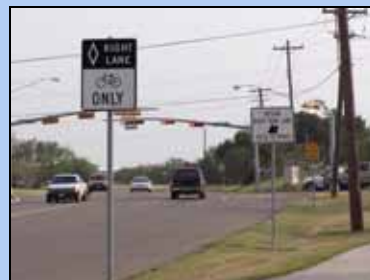
Photo Depiction

Conditions: Jaycee Park is in good condition and received a composite score of 1.08. Natural shade through vegetative plantings and benches are required around the jungle gym area to provide a place to rest and shade for children and adults. The sheltered picnic area requires some maintenance to address minor graffiti and surface cracking. The basketball nets need to be replaced. Improved walking surfaces (e.g. sidewalks) are required. While 20th Avenue has appropriate signage to encourage motorists to reduce speed, similar signage is lacking on other perimeter streets. Crosswalks are also needed to increase safety.

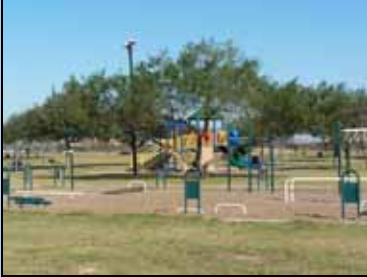
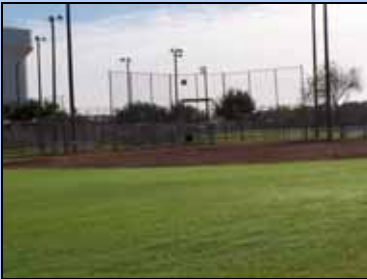
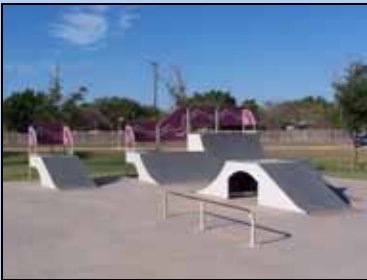
Photo Depiction

Conditions: Freddy Gonzalez received a composite score which indicated that it is in good condition (1.00). Turf conditions are particularly poor (i.e. dry and patchy) on the slope along 17th Street. To improve safety, crosswalks, signage, and sidewalks are required. Lighting is also required around the jungle gym to provide safety. Sheltered picnic tables and grills do not exist. The park would benefit from these amenities.

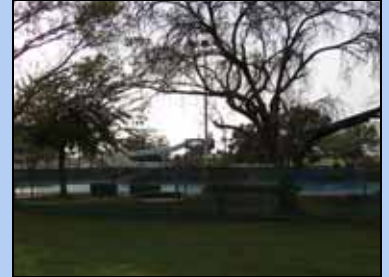
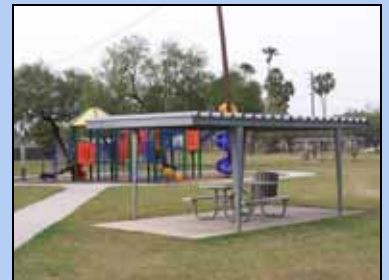
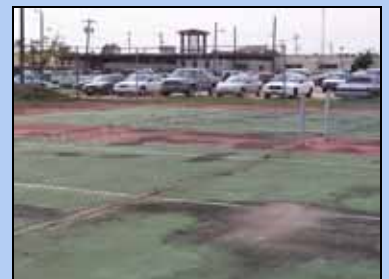
Photo Depiction

Conditions: The park was assessed to be in good condition, having received a composite score of 1.00. However, improvements are still required, particularly as they relate to accessibility. Handicap parking must be made available at the parking lot on the east side of the park. The other parking lot is in poor condition (e.g. faded paint, crevices, ponding) and needs reconstruction. A drainage/irrigation canal running parallel to Sprague Street acts as a physical barrier to the park, potentially creating a safety hazard. Signage must be added to Sprague Street. Natural screening and/or attractive signage should also be considered for Sprague Street. While Jackson Road is a major street, there are no crosswalks or signs to allow pedestrians to cross safely. Improvements must be made to increase accessibility.

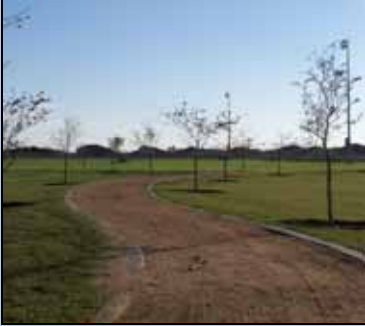
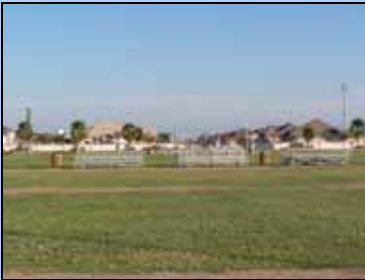
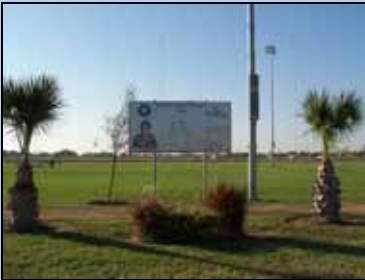
Photo Depiction

Conditions: The park is in poor condition relative to other municipal parks as it received a composite score of 1.83. Sports equipment needs to be maintained and/or replaced. For example, the basketball nets are in poor condition. The tennis court nets consist of chain link fencing and must be replaced. Fencing around the tennis courts is also in poor condition. The courts are not entirely fenced, yet the court abuts a parking lot (see photo). Accessibility is also an issue of concern, particularly along Freddy Gonzalez Drive. Users access the park via a fenced bridge, which goes over a water drainage/irrigation canal. The fencing on the bridge is in disrepair and unsafe.

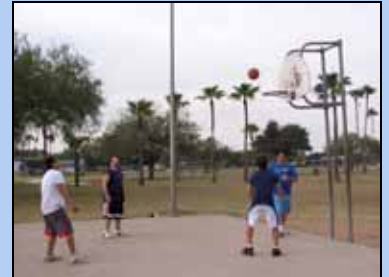
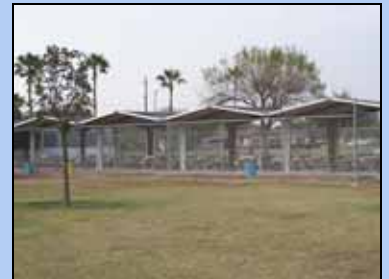
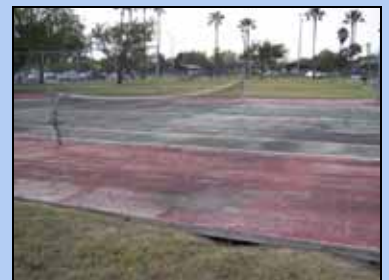
Photo Depiction

Conditions: The park is in very good condition. During the park assessment, it received a 0.73 composite score. Compared to other parks which are typically dry, the turf is in good condition. However, some re-seeding is required on the playing fields. Crushed stone that is used along the trail is good for natural infiltration, but is not good in terms of accessibility for persons with disabilities. Some paved surfaces are required to provide barrier-free access around the park. Some minor ponding on the south side of the trail suggests some drainage issues. More shelter is required to provide shade to park users. Crosswalks are required along Mon Mack Road to provide safety for pedestrians.
